Seismic performance of a post-tensioned LVL building subjected to the Canterbury earthquake sequence

**2012 NZSEE
Conference**

ABSTRACT: The following paper presents the seismic performance of a two storey post-tensioned Laminated Veneer Lumber (LVL) building during the aftershock sequence following the MW 6.3 Canterbury earthquake that occurred on 22nd February 2011. Composed of post-tensioned walls in one direction and post-tensioned frames in the other, the structure under analysis was originally tested quasi-statically in the structural laboratories of the University of Canterbury (UoC), Christchurch, New Zealand. Following testing the building was demounted and reassembled as the offices of the STIC (Structural Timber Innovation Company) research consortium on the UoC campus with several significant changes being made to convert the building from its initial use as a test specimen into a functioning office structure.

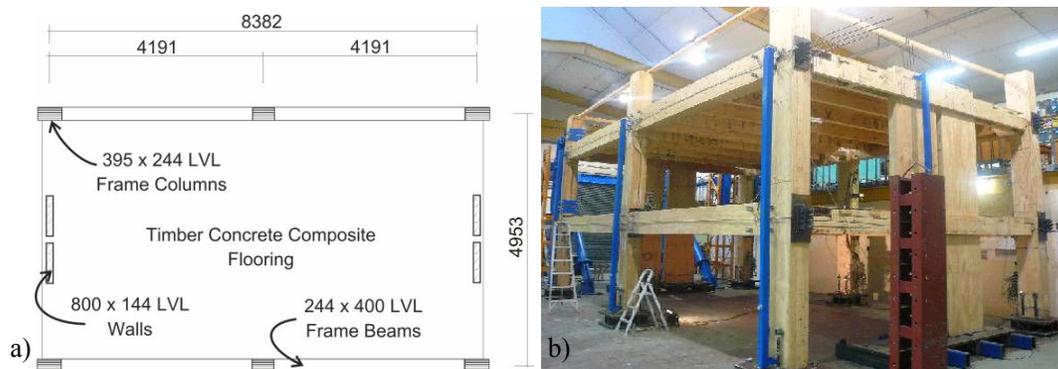
The structure which was analysed was initially a two storey test structure which was subjected to a series of quasi-static tests in the structural laboratory of the University of Canterbury. The two storey structure was a frame and wall open plan building as shown in Figure 1. The building consisted of lateral resisting post-tensioned timber frames in one direction and post-tensioned shear walls in the opposite direction. The floor of the structure, which was of area 41m² on two levels (i.e. a total area of 82m²), was a timber concrete composite flooring system developed at the University of Canterbury, consisting of LVL joists and 50 mm of topping concrete connected with notch and coach screw discrete couplers (Yeoh 2010). Due to the structure being a research specimen the floors spanned in two different directions, with the flooring spanning in the long (Frame) direction on the lower floor.

Figure 1. Pres-Lam Test Building a) Floor Plan and b) Constructed Test Building

Quasi-static cyclic testing was performed in both the frame and wall directions separately as well as simultaneously. The test building displayed excellent seismic performance with complete recentering and no significant damage up to 2% drift (Newcombe et al. 2010). It was noted that the simultaneous bi-directional loading had no major effect on the in-plane resistance the frames or walls. Once the Pres-Lam test building was completed, a proposal was made to recycle the structural components to form a new office structure for STIC, the Structural Timber Innovation Company (Fig. 2).

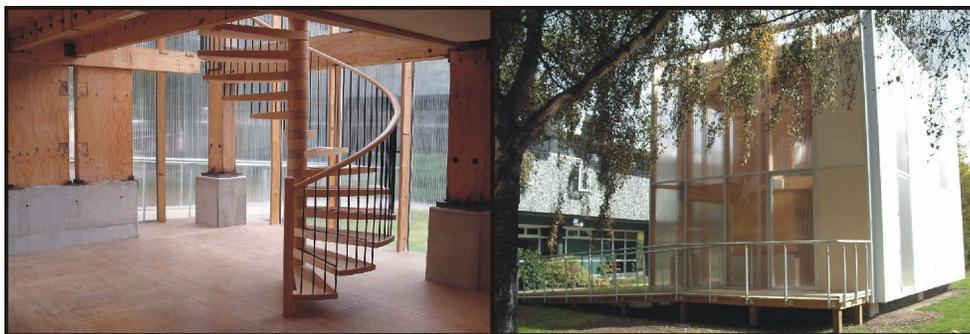
Figure 2. The Expan Office Structure for STIC

To transform the experimental building into a new office building, most components of the existing experimental building would be fully utilised. In total over 90% of the structural components were

able to be reused (Smith et al. 2011), however due to the original purpose as a 2/3 scale test specimen, some changes had to be made. The building was designed before the September earthquake therefore, the codes in place at the time were used in design (Z for Canterbury = 0.22). The building was estimated to have a fundamental period of 0.34 seconds. The building was given an Importance Level of 2 and due to the temporary nature of the building a 10 year design life was assumed ($R_{ULS} = 0.75$).

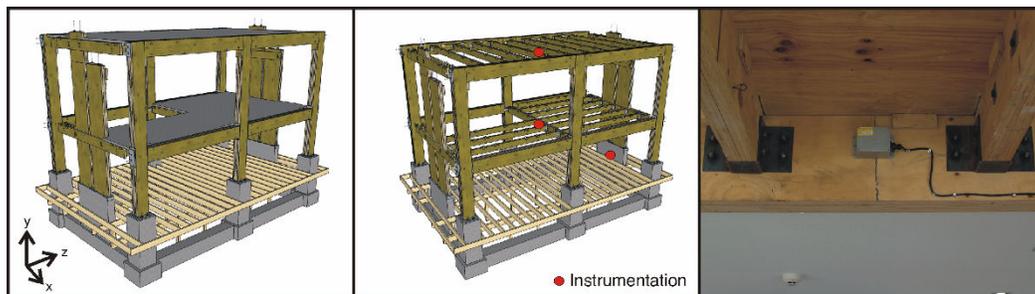
The structure was almost fully complete when the February 22nd event occurred however instrumentation had not been yet installed. Instrumentation was installed on the Expan building at the end of March 2011 and consisted of three triaxial accelerometers mounted at the foundation, first floor and second floor. As shown in Figure 3, the first and second floor accelerometers were positioned in the centre of the central beam, while the foundation accelerometer is near the west end of the structure.

Figure 3. Instrumentation layout placed on the Expan building, showing axes for recorded accelerations. Note the varying purlin layout at each level, and the irregular concrete diaphragm.

The first thing that can be noted from Figure 10 is that the fundamental frequency of the building in both directions is approximately 5.5 Hz which gives a fundamental period of 0.18 seconds. This is lower than the estimated value which was used in design ($T = 0.34$ s). The closeness of the two values indicates that probably a torsional mode is governing the system response. This is possible and may be arising from the large section of floor which was removed in order to allow for the stairs (Fig. 3.)

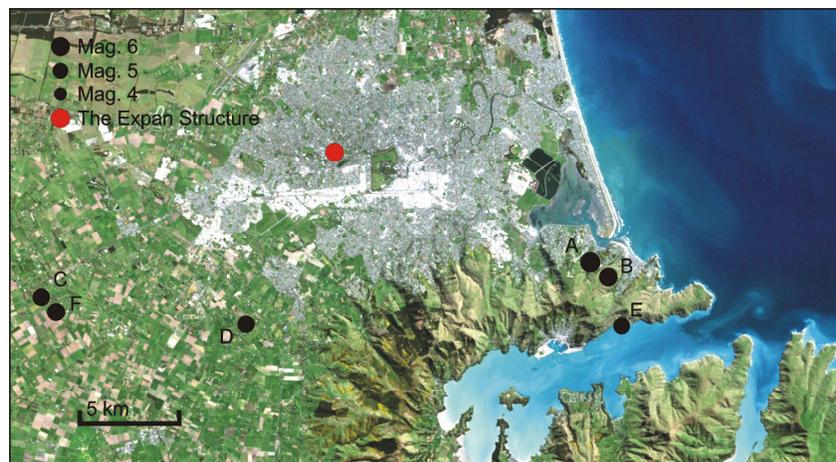
Following the installation of the instrumentation trigger thresholds have been surpassed over 1000 times leading to a significant database of records available to the current research. In this paper a selection of 6 records have been chosen based on the largest acceleration measured at the second storey of the building between the installation of the instrumentation and the 1st of October 2011. Information regarding the selected records is presented in Table 1 and shown in Figure 4. Accelerations shown refer to the records at the building foundation in the Z (frame) direction.

Figure 4. Studied Earthquakes in Relation to Expan Structure (NASA Satellite Image)

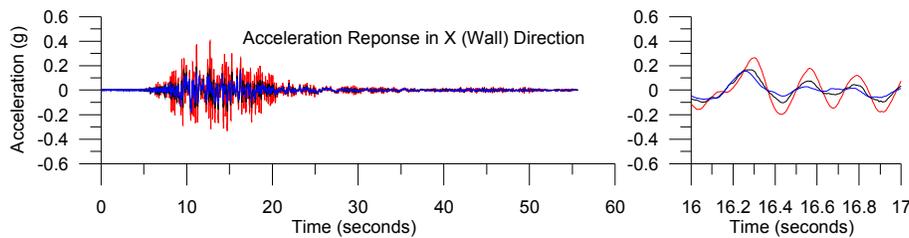
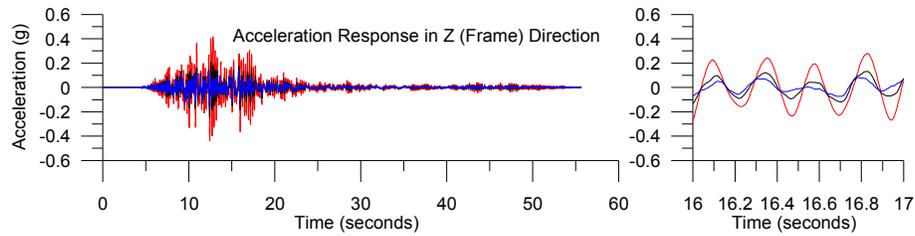
Figure 5 and Figure 6 show the time-history response of the building under the largest recorded excitation for the period selected (A, the 13th of June Event). Along with the full time-history, a window has been shown between 16 and 17 seconds in order to show clearly the dynamic response of the building. It can be seen that a significant increase in acceleration occurs from the base of the structure to the 3rd floor with this effect being larger in the Z (frame) Direction.

Figure 5. Time History Response in X (Wall) Direction for Earthquake A – 13th June 2011 2:20 pm (Blue – Ground, Black – First Floor, Red – Second Floor)

Figure 6. Time History Response in Z (Frame) Direction for Earthquake A – 13th June 2011 2:20 pm (Blue – Ground, Black – First Floor, Red – Second Floor)

The time histories of these records have been studied and show that a significant increase in acceleration is registered from ground input to the second storey with this effect being more severe in the frame direction. All signals were analyzed using both a standard approach, based on the response

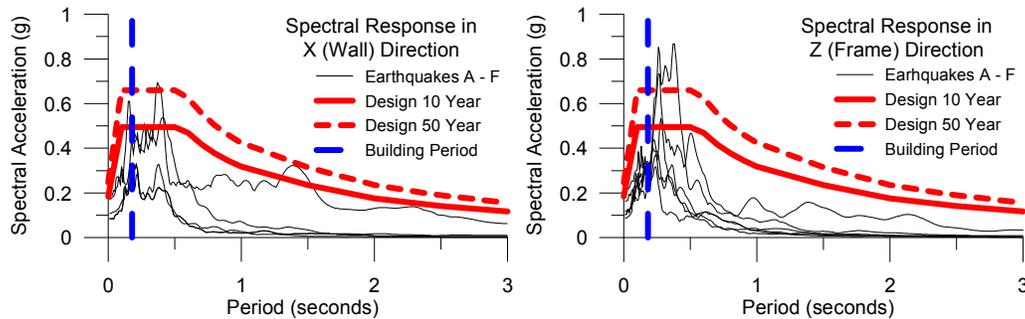
The acceleration spectra for the six selected earthquakes are shown in Figure 7. Along with the recorded responses the thick red line shows the design spectrum used and derived from the design parameters stated in Section 1.2.

Figure 7. Acceleration Spectra for Selected Records

Direct comparison between the input spectra and design spectrum shows that on more than one occasion input has been either equal to or above the 10 year design value and in one case approaches the 50 year design value in the range of the building period (calculated to be 0.18 as shown in Section 3.5 and shown as a blue dashed line in Figure 7).

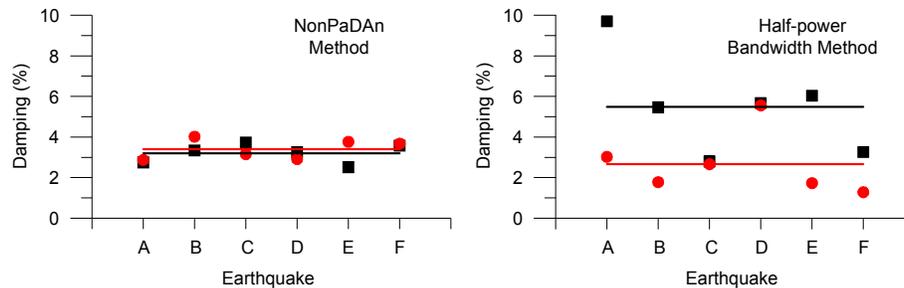
damping factor is estimated using the logarithmic decrement method on a minimum of three consecutive decreasing peaks separated by the same period T (within a bracket of \pm the tolerance level (ϵ) as a function of T). The values obtained using the two methods are shown in Figure 8 which shows the damping in the X (black squares) and Z (red dots) along with the average of the values (red and black continuous lines for X and Z direction respectively).

Figure 8. Damping of Expan Building Under Excitation

The above figure shows that the NonPaDAn method is more stable than the HPB method as it is more appropriate for use under the given conditions (i.e. a forced system situation). The results of the NonPaDAn method show nominal damping in the system of between 3 and 4%. It should be noted however that this value is an average of damping obtained throughout the full seismic event. It is therefore possible that damping increases above this range during strong motion. Work is ongoing in the investigation of damping over time.

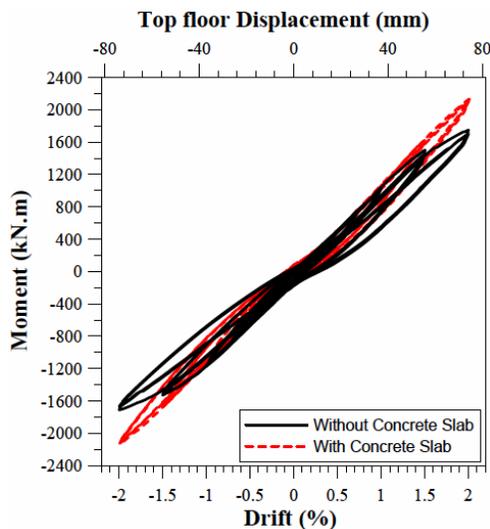
Figure 9. Force-displacement of Pres Lam Test building under Quasi Static Excitation (Frame Direction)

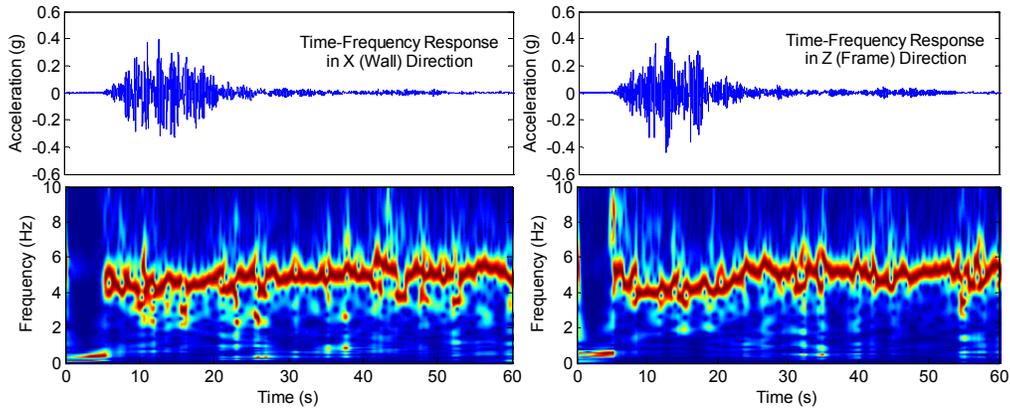
Where: t = time, f = frequency and τ = a parameter that controls the position of a Gaussian window along the time axis. This method of analysis has been used on the selected records with the results of the analysis of Earthquake A shown in Figure 10. In the figure, the output of the S-Transform has been normalized in order improve clarity.

Figure 10. S-Transform of Earthquake A in X and Z direction given Time Frequency Response

Figure 10 also shows the nature of the non-linear elastic system. More evident in the Z direction than the X direction, there is a clear drop in frequency (to around 4 Hz or 0.25 s) during excitation which is fully recovered following the seismic event. If this analysis is performed on a system which is damaged during the event the frequency of the structure will not return to its original value but instead to a third ‘post-event’ value (Ponzo et al. 2010). This is not the case however as the original stiffness of the structure is regained as the building returns to its original position damage free.
