Structural Health Monitoring (SHM) by a wireless mesh network of accelerometers: the example of L'Aquila (Italy) seismic sequence, 2009.

M. Picozzi, S. Parolai, C. Milkereit, D. Bindi & J. Zschau Helmholtz-Zentrum Potsdam Deutsches GeoForschungsZentrum, Telegrafenberg, 14473 Potsdam, Germany.

Department of Structures, Geotechnics, Applied Geology, University of Basilicata, Potenza, Italy.

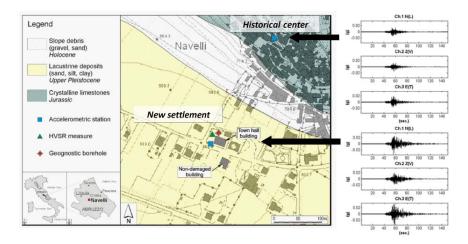
Figure 1: Geological map of the southern sector of Navelli; location of accelerometric stations in the town hall and at historical center; ground motion recorded at the historical centre of Navelli during the 2 event (Table 1), and at the new settlements in the plain.

In order to characterize the site response of the new settlement area, a Kinemetrics Altus K2 accelerometer was installed at the ground floor of Navelli's town hall in the plain, while another K2 accelerometer was installed at the historical center of Navelli. Figure (1) shows a comparison of waveforms recorded by two stations during the 2^{nd} strongest aftershock of the sequence (i.e. the Ml = 5.1 of the April 9). It is clear that for the same seismic input, the city hall experienced much larger ground motion amplitudes with respect to the historical center.

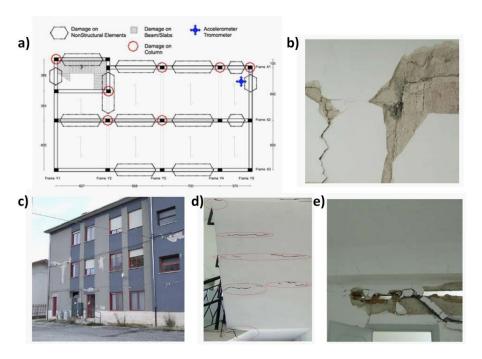
Figure 2: Damage state of the Navelli's town hall. *a)* View of the building plan showing where the accelerometric sensors were installed, and the location of significant structural and non-structural damage. *b)* Damage on columns along the frame at the first storey. *c)* Damage on infill panels along the transversal direction. *d)* Damage on staircase structural elements. *e)* Damage on non-structural elements in the frame at the first storey.

The Navelli's town hall is a Reinforced Concrete (RC) framed structure with three stories and two by four bays (Figure 2). It was designed and constructed in the '60s. Hence, it does not follow the current seismic design criteria of symmetry, bi-directional resistance, stiffness, capacity design, and the local and global ductility demand. In fact, owing to the presence of a stiff stair structure placed in an eccentric position, the structure is irregular in a plan-view drawing. The structure has the dimensions of 23.55 m and 12.42 m for the longitudinal and transversal directions. By contrast, in elevation the building's shape is approximately regular, with an interstorey height of 3.5m. Unfortunately, a direct inspection of the foundations was not possible. Therefore, we assume that they are shallow, according to the standard of building design at the time when the structure was built.

Mucciarelli et al. (2010) found that the strong damage resulting from the main shock compromised the usability of the building, and affected beams, columns, beam-column joints and the staircase (Figure 2).

It is worth noting that columns' damage was particularly heavy and extensive at the first level. Furthermore, cracking on the external masonry infill were observed along the longitudinal and transversal frame at the ground and first stories. Moreover, several cracks occurred across the diagonals of external panels and also on internal partitions. A possible contribute to the resulting structural damage might have been caused by the presence of a historic archive of the municipality, which was placed on the upper floor in an eccentric position.

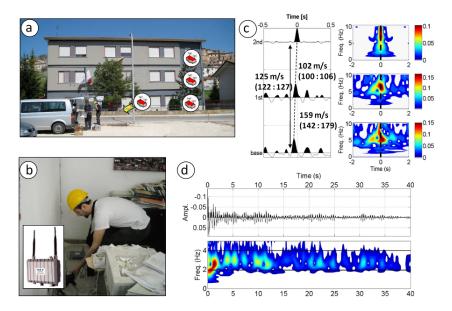
Figure 3: *a*) and *b*) The Navelli's city hall and installation of the SOSEWIN units. *c*) IRF from interferometry (*left panels*) for event 2 and using the sensor at the top of the Navelli city hall as reference, and their time-frequency representation by S-transform (*right panel*). The interval and global velocity estimates are also indicated together with the uncertainty interval, as well as the travel times between the pulses at different floors. *d*) IRF for the 2nd floor and event 2 (*upper panel*) using the signal at the base as reference, and its time-frequency representation (*lower panel*) by S-transform.

In order to perform a continuous monitoring of the building, the town hall was instrumented with four SOSEWIN accelerometric stations. The network was composed by one station for each floor (Figure 3a, b), installed on the same vertical along the building height, and one station buried in the ground near the building. The data collected by the system were analyzed for SHM purposes by both standard frequency-domain and innovative time domain approaches.

Figures (3c) shows the IRF and the relevant S-transform estimated for an event with magnitude ML equal to 5.1. The analysis has been performed using the whole earthquake recording, that is to say including P, S and the following phases, for a total time of 40 seconds. The IRF was obtained from the deconvolution of signals using the recording at the top and at the base as reference. By picking the maximum of the pulses showing up for the different levels, it was possible to retrieve the wave travel time, and hence, the interval (i.e. relevant to the single floors) and the global velocities (i.e. from the travel time difference of the sensors at top and at the base) were estimated (Figures 3c).

Figure (3d) shows the IRF and it time-frequency representation. This latter allows observing the variation between about 2 Hz (0.5 sec.) and about 3 Hz (0.33 sec.) of the maximum of the energy over time. Considering that the IRF functions was estimated by deconvolving signals recorded within the structure, it is independent both of the excitation of the building, and of soil-structure interactions. Therefore, the resonance frequencies estimated from the time-frequency representation of IRF in Figure (3d) is interpreted as the fundamental resonance frequency (f_I) of the building.
